# Reconstruction of the Old Bridge of Mostar

M. Popovac

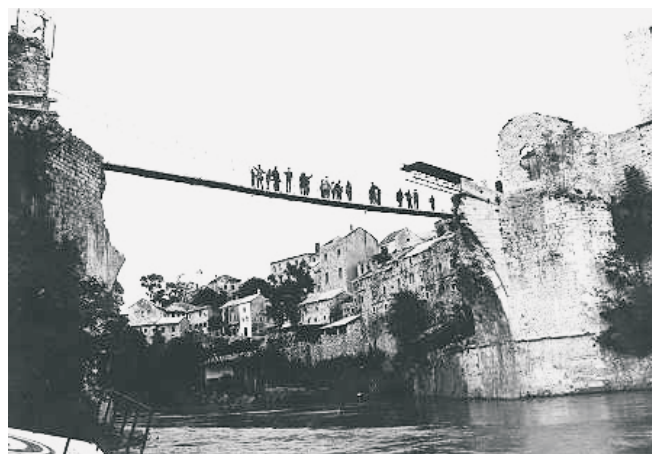
Fig. 3: Destroyed bridge – south elevation

An analysis of the remaining portions of the bridge near the east abutment, shows that there was greater surface deterioration on the north side than on the south side. The shelling came from the south side, and hit mostly the south east portion of the bridge over the arch reins: the most extensive remaining portions of the bridge were located on that side. Shootings was also directed at the north elevation during other attacks, and for this reason the bridge was protected by tyres, ( the temporary structures over the footpath were intended to protect people from gunfire). Shelling was directed at a single spot in order to destroy the structure with the minimum numbers of shells. The structure was divided into two main parts: a small part below the arch reins on the east bank, and a big part which was totally blown into the river.

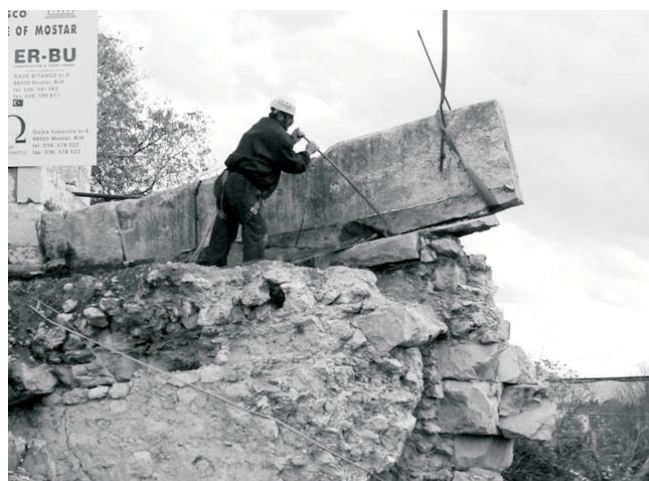
Fig. 7: Dismantling the remnants of the bridge on the south east side

On 19<sup>th</sup> November 2002, the remnants of the bridge on the left bank of the Neretva began to be dismantled. This task was very delicate because the console of the bridge that remained after demolition was in very bad condition. Structural fractures were visible. There was no solid support under this part of the bridge for auxiliary structure, which made the job even more difficult. Each dismantled stone was marked and taken away.

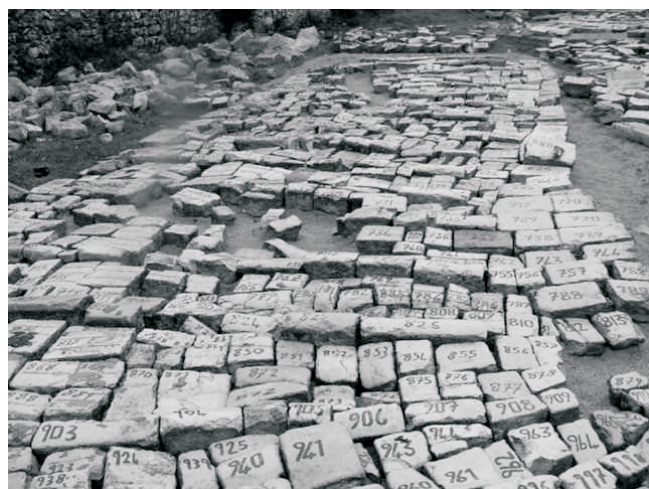
Fig. 8: Pavement stones in their new location

measured. Due to its irregular surface and its particularly visible position, the pavement was one of the most delicate dismantling and rebuilding tasks. It was a very delicate job, because it was important to return the largest possible number of stones to their original place. The workers, using hand tools, separated each stone individually from the mortar, silicon and soil.

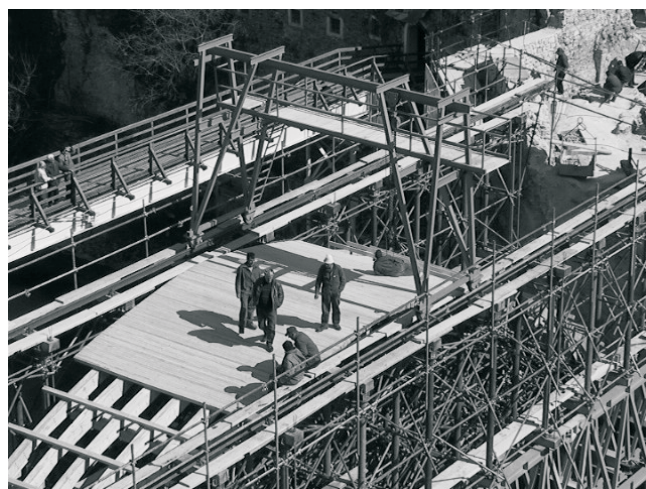
Fig. 10: Portal crane

While the centering was being mounted, the portal crane structure was also being set up. The portal crane was needed to ensure that the arch was assembled with precision.

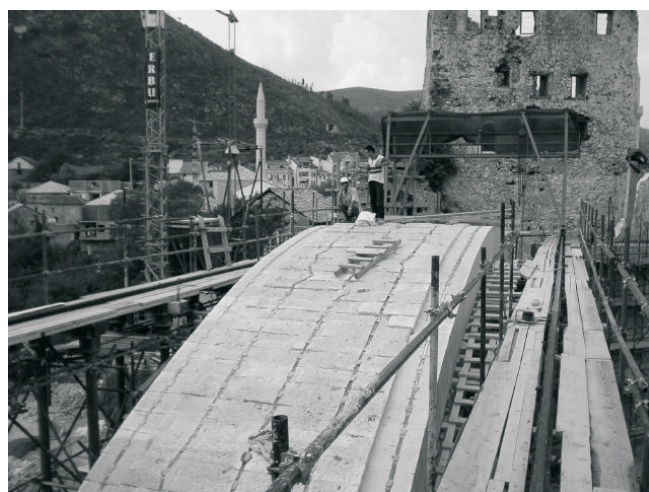
Fig. 12: Load bearing arch completed

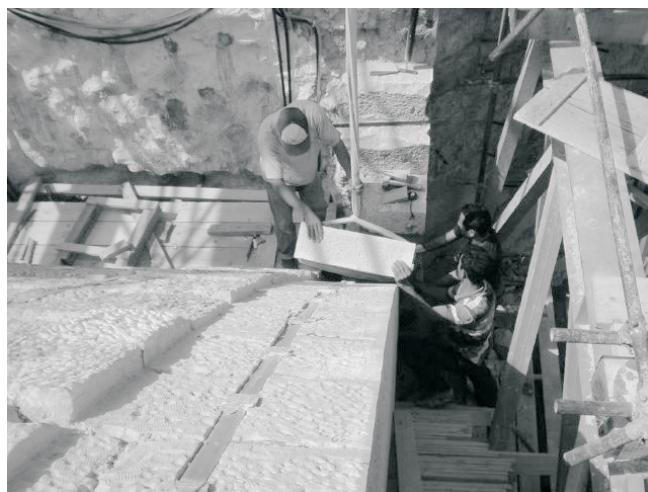
Fig. 16: Assembling the cornices

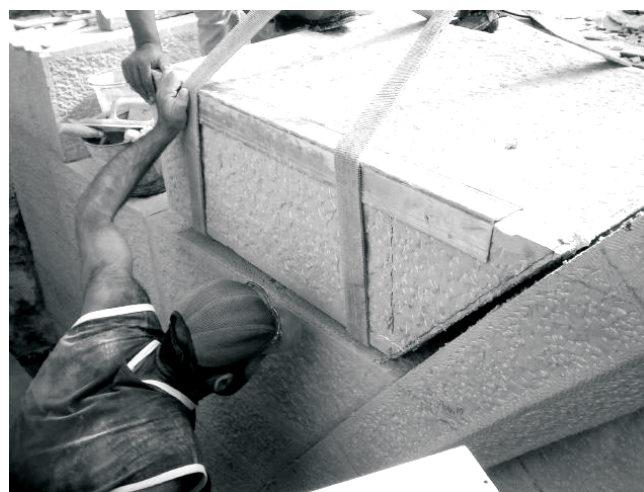
Fig. 18: Assembling the spandrel stones

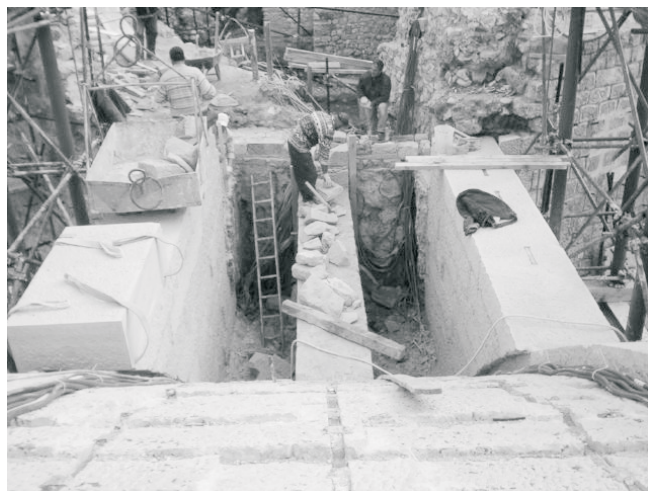
Fig. 20: Assembling the upper cornice

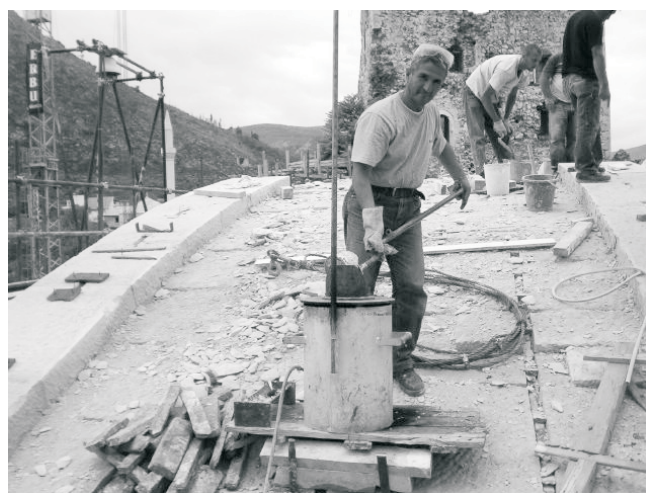
Fig. 23: Lead melting can

One of the most important materials used in constructing the bridge was lead. The bridge itself was an organic structure, capable of resisting various kinds of pressures: strong wind, the river, earthquakes, etc. This kind of flexibility was achieved with the use of metal cramps and dowels, fixed within the stone cavities with lead. Lead was melted at 380–390 °C, in a special heater, and poured into the hole using a small can.

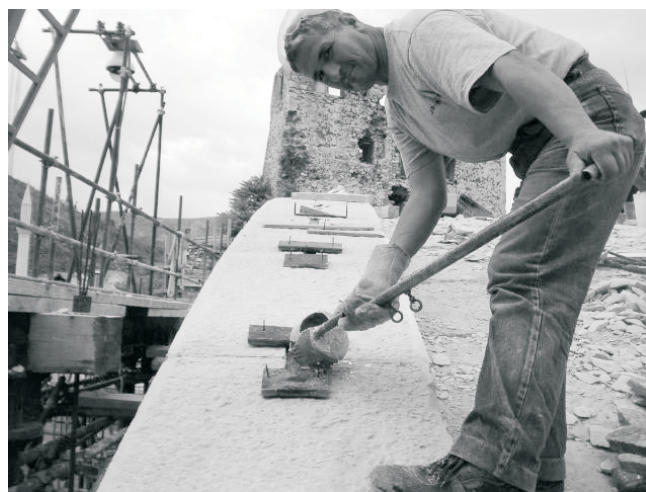
Fig. 24: Pouring the lead

One of the most important and most delicate procedures while building the bridge was pouring the lead into the voussoir stones. Lead was poured through channels into the “hidden” (already inserted) dowels between the rows of the arch. The channels had to be dry and clean, and the lead had to be poured at the optimum rate. This dangerous procedure was performed with 100% success.

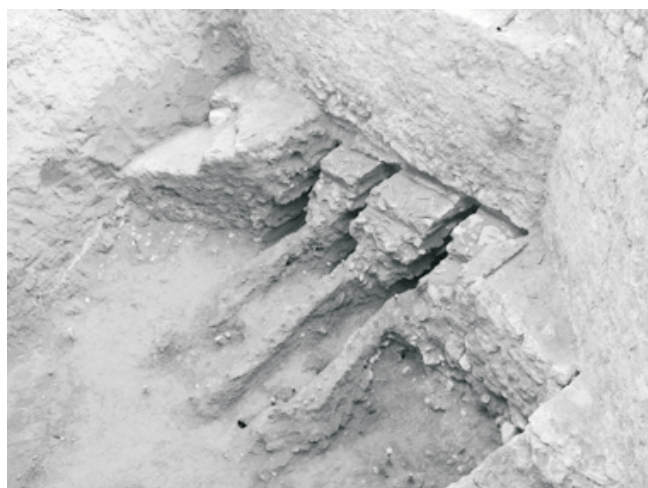
Fig. 26: Traces of the beams for the suspension bridge

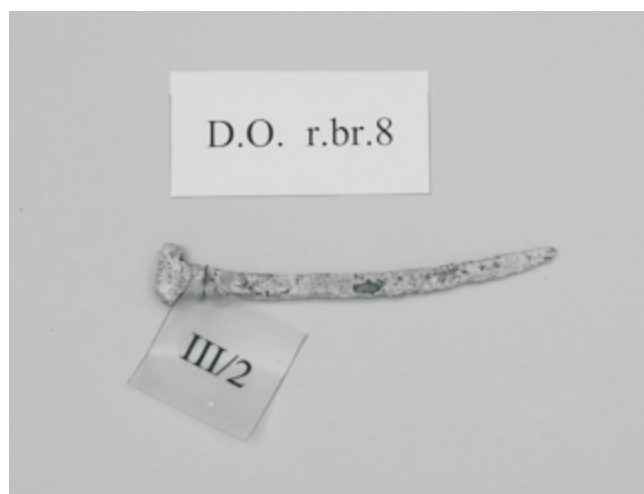
Fig. 27: Huge iron nail from the suspension bridge

About 200 pieces of pottery were found on the site – dating from the 15<sup>th</sup> to 20<sup>th</sup> century, about twenty stone and one metal cannon balls, about 250 metal wedges from the structure of wooden bridge, one copper coin and several mediaeval tools.

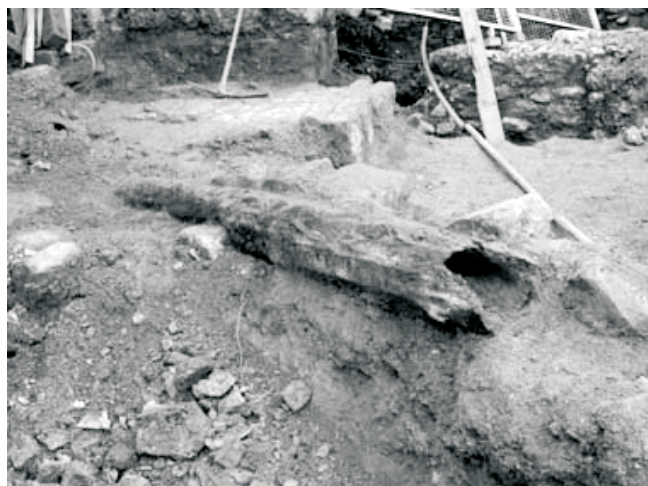
Fig. 28: Wooden pipe covered in terra rossa
