RECONSTRUCTION OF ČEJVAN – ĆEHAJIN HAMMAM IN MOSTAR

Abstract:

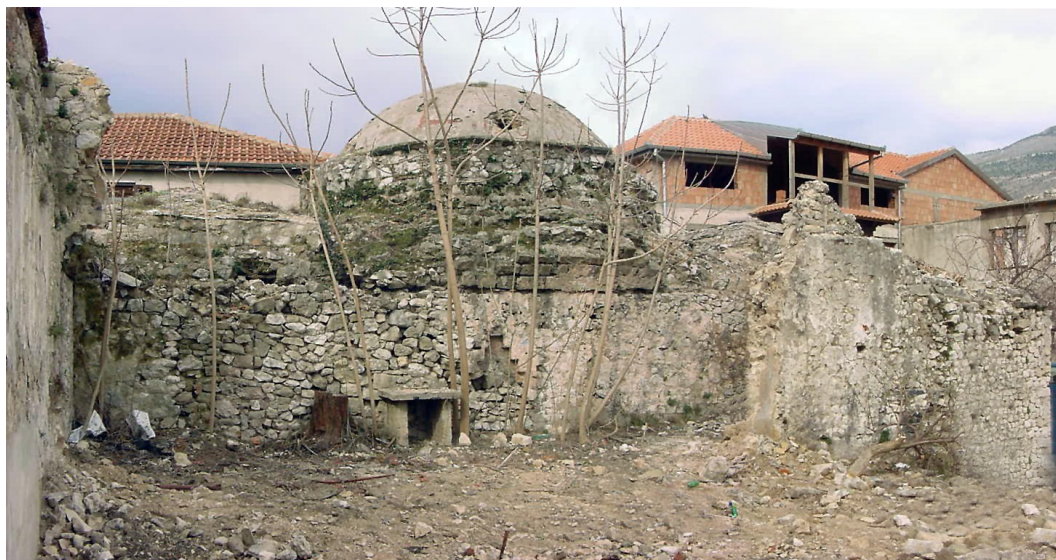
Fig. 3. Čejvan – Čehajin Hammam in 2002, South façade

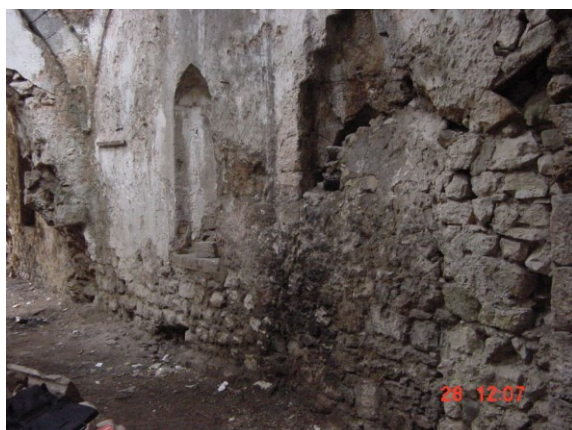
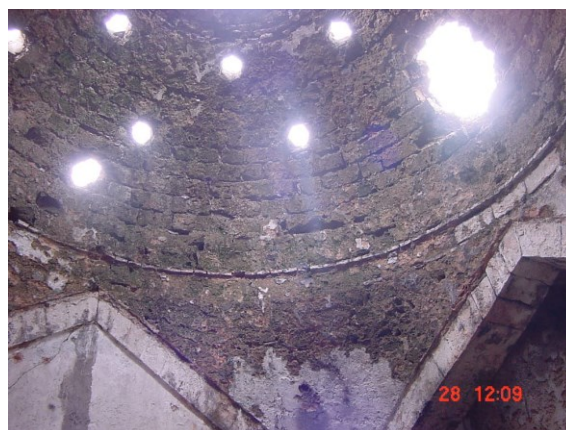
Fig. 4. Čejvan – Čehajin Hammam in 2002: a) main room; b) dome

Central space of Šadrvan was divided by the pointed arch to two separate ceilings - dome on bigger span, and small barrel vault on the north side. Entire structure of the dome

is based on four pointed arches made of beautifully chiseled limestone. On three sides the arches were within the massive walls.

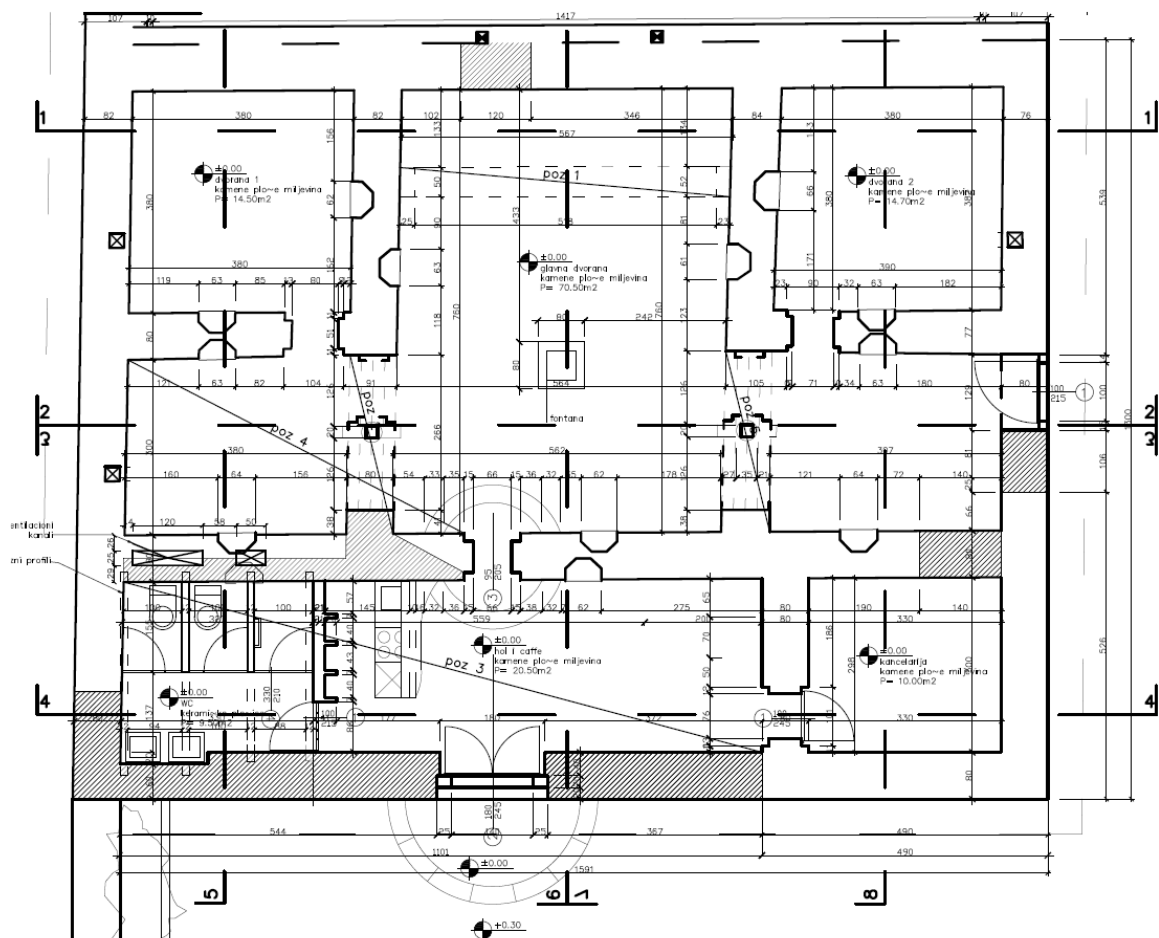
Fig. 5. Čejvan – Čehajin Hammam - layout

The building of Hammam kept all of its basic layout elements except Hazna and Ćulhan at the north side. These parts were demolished probably during the 19th century and become part of a private estate on the north and west side. They are recognizable only in segments of the stone arch that was made of beautifully carved travertine and whose vertical dimensions was significantly lower than the rest of the building. By comparing with similar structures it was concluded that this space was covered by stone slab on slope roof structure. Due to the devastation of the west wall, ceramic water pipes, functioning on the principle of connected vessels, were visible.

The layout of the Hammam was symmetrical – on the western and eastern side from Šadrvan we have two rooms with groin vaults, from where we can enter two separate rooms on the north-west and north-east corners covered with domes.

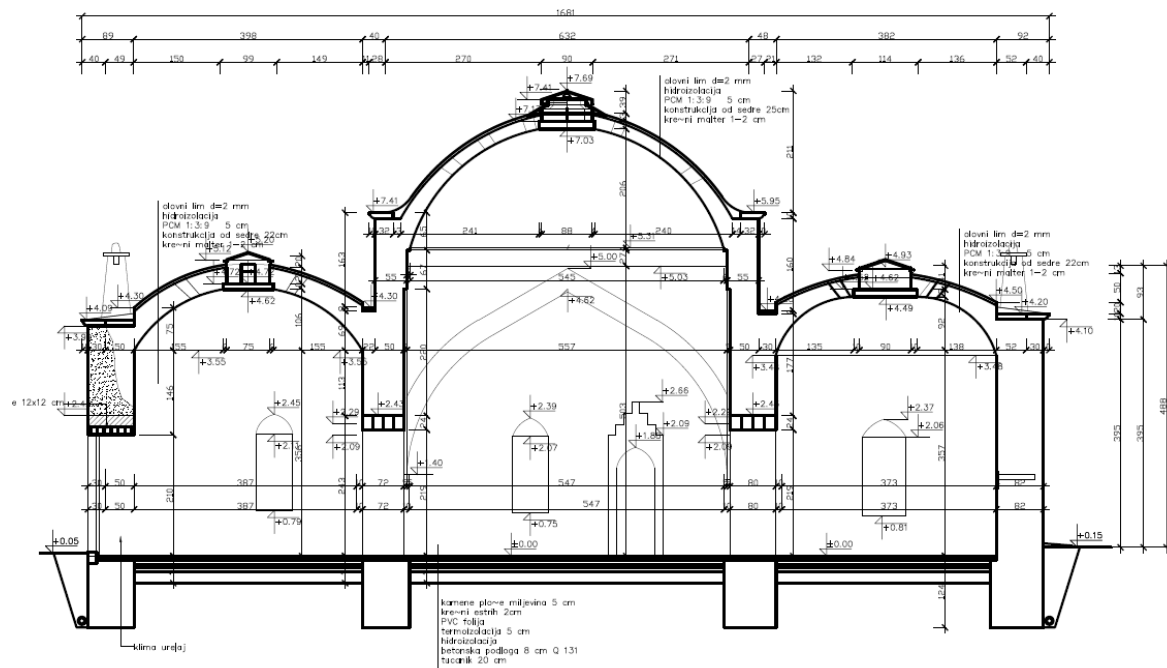
Fig. 7. Čejvan – Ćehajin Hammam – cross-section

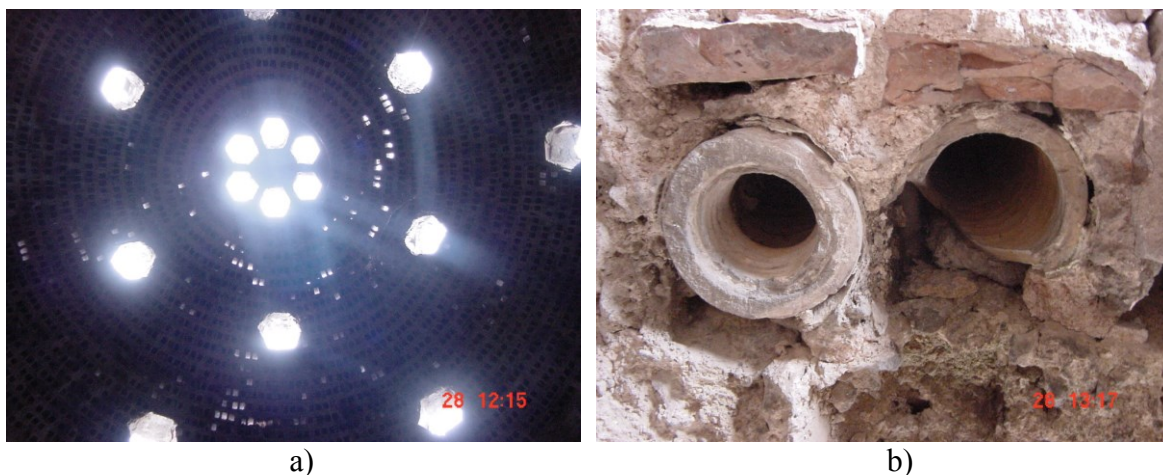
Fig. 8. Hammam in 2002: a) north-east dome; b) ceramic pipes

Big dome and all barrel and groin vaults were made of tufa stone, and two small domes were made of thin brick blocks. North-east small dome was reconstructed in 1954 and was made from contemporary brick in cement mortar. Under all domes and vaults there is one row of thin brick that was placed on top of the stone walls.

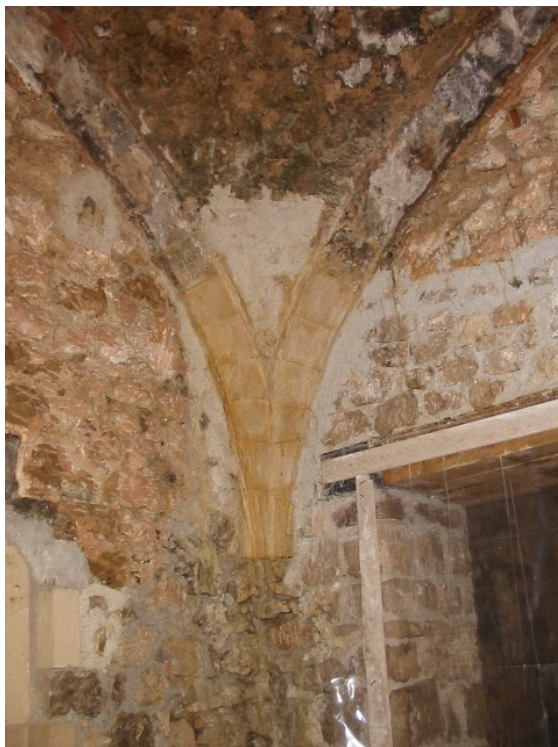
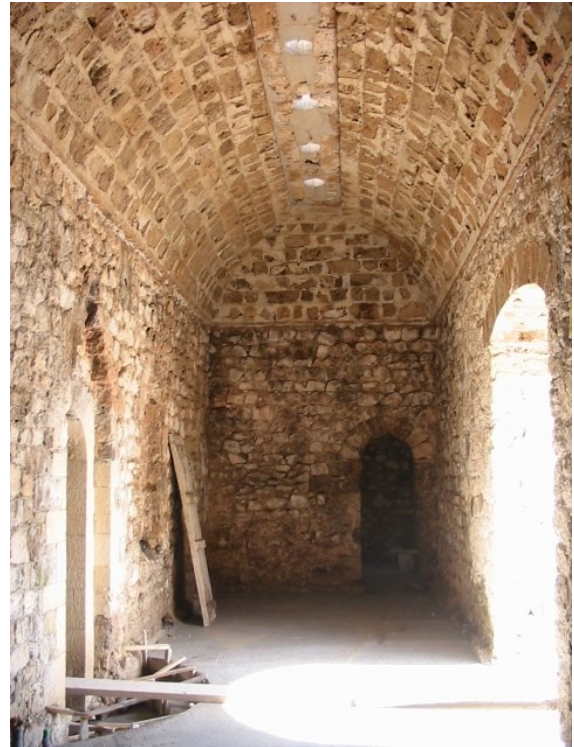
Fig. 9. Hammam in 2004: a) repaired pointed arch in main room; b) entrance barell vault

First it was important to consolidate the foundations on the south side. After that it was possible to start with masonry works on the south wall. Clear distinction of the new and old wall was made by performing the line between them in form of wider joint. After the wall was finished, the layer of thin bricks was laid as the base for the barrel vault made of tufa stone. With that, the Hamam was ready for the winter – the works inside of the Hammam could start. As the walls inside of the Hammam were partially unstable and some of the arches needed serious repair and change of the blocks, it was necessary to build the scaffolding and centering for the arches.

The domes and vaults were repaired and covered with thin lime mortar coat under the lead shroud. Special convex glass elements were ordered for the openings on the roof, and above the central dome we installed the skylight similar to the ones on same structures.
